REPAIR, EVALUATION, MAINTENANCE, AND
REHABILITATION RESEARCH PROGRAM

TECHNICAL REPORT REMR-GT-17

APPLICATIONS AND TESTING
OF RESIN GROUTED ROCKBOLTS

Final Report

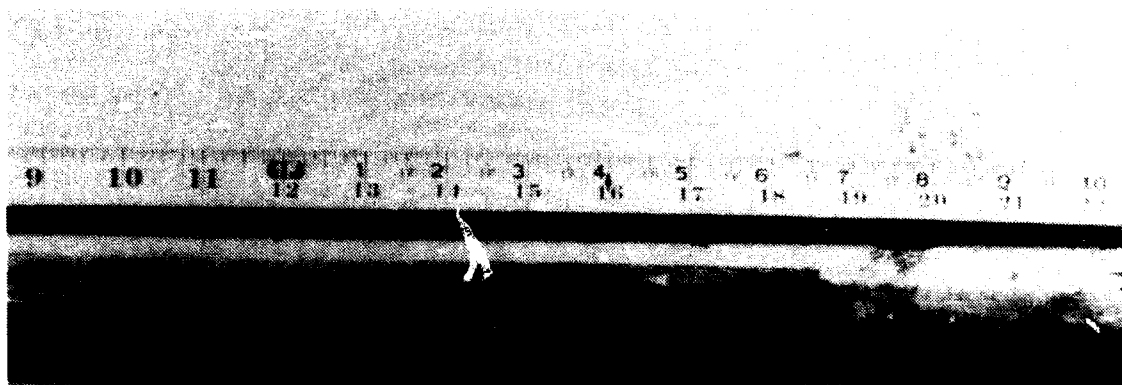
Figure 5. WES two-cartridge test, lower portion

SPIN TIME: 15 SECONDS
WET
TWO RESIN CARTRIDGES
 $\frac{3}{16}$ -6
 $\frac{3}{4}$ "-1"

49. The simple tests conducted in PVC tubes revealed important clues into the interaction between water and resin. The blending of resin and water took place in the top 12 to 14 in. of the resin column, regardless of whether one or two cartridges of resin were used. The near total dilution of the top 12 in. of resin helps to explain the poor performance of the 15-in. Singleton tests of resin bolts installed under submerged conditions.
